AVIATION INVESTIGATION REPORT

A00P0182

INPUT FREEWHEEL UNIT MALFUNCTION

SIKORSKY S-61N/SP (HELICOPTER) C-GHJU

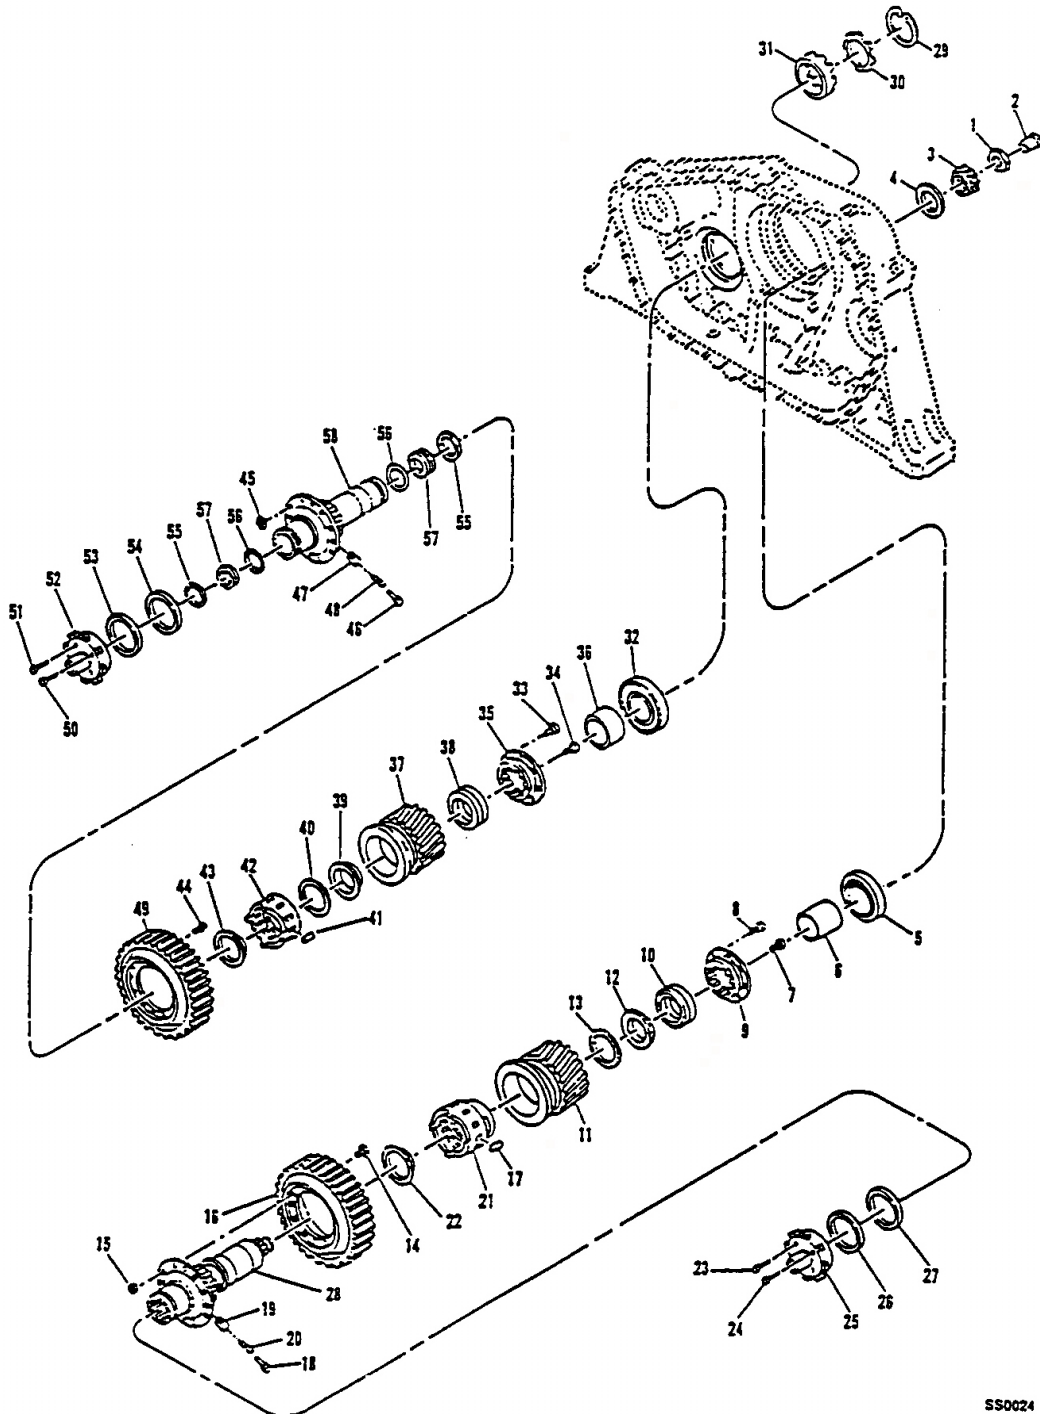
FIGURE 149A. MAIN GEAR BOX INPUT FREE WHEEL UNIT QUICK CHANGE ASSEMBLY

The main-rotor gearbox was removed, disassembled, and examined. With the exception of the No. 2 (right) input freewheel unit (IFWU), no defect was found. The No. 2 IFWU was disassembled and examined (see Appendix A). The IFWU gear housing was found to have been worn well beyond tolerance; the wear was eccentric, and the wear depth was greater than normally seen in a component with similar in-service life.

The maximum permitted internal dimension of an S-61 IFWU gear housing at overhaul is 3.7535 inches. In places, the internal dimension of the No. 2 IFWU housing was 3.7595 inches: the wear was 0.0059 inch greater than the rejection limit. Furthermore, the wear was eccentric and 0.0045 inch out of round. In comparison, the No. 1 (left) IFWU gear housing showed less than 0.001 inch of uniform wear.

Accelerated wear in the IFWU was likely caused by a combination of frequent overrunning of the same IFWU, frequent single-engine training, and rotor engagement techniques. It was not determined why the No. 2 IFWU gear housing had worn in an eccentric manner.

As a result of this incident, Helijet implemented an improved starting and engagement procedure with its S-61N helicopter. This procedure involved starting both engines and then engaging the rotors with both engines together, which significantly reduces overrun. The operator reduced the maintenance inspection cycle for the IFWUs to 300 hours in service to see if the wear was affected by the new operating procedures. An inspection of the main-rotor gearbox was carried out on 31 January 2001, 300 hours in service since the original freewheel slippage event that is the subject of this investigation. That examination of the No. 2 IFWU revealed wear on the cam and the rollers but virtually none on the IFWU housing. Helijet replaced the IFWU and has scheduled another inspection of this IFWU after 450 hours of service.
